Manhole Inspection Summary

Manhole # S17G__012MH

Insp Date: **10/4/07 3:42 PM**

Location Address: **2401 LEXUBGTON-FAYETTE** Cross Street: **WHEELER AVE**

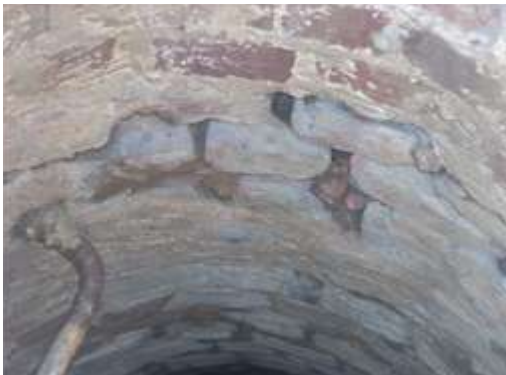
Defect 4

Corbel Material: **Brick** ☐ Parged Type: **Concentric/Eccentric**
Condition: ☐ Sound ☐ Cracked ☐ Root Intrusion ☐ Loose Brick ☒ **Deteriorated**
Infiltration: ☒ None ☐ Joint ☐ Cracks ☐ Mortar ☐ Roots ☐ Wall

CORBEL DETERIOATION

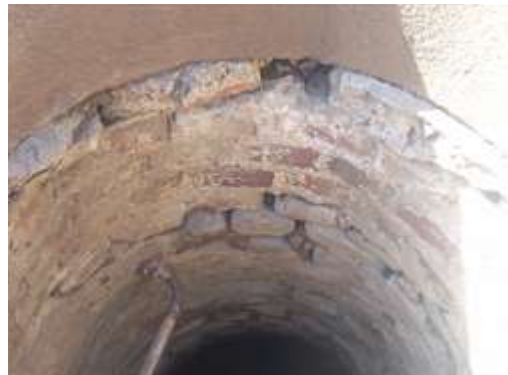
Defect 3

Chimney / Frame Adjustment ☒ Exists Material: **Brick and Concrete** ☐ Parged Height: **6** (in.)
Condition: ☐ Sound ☐ Cracked ☐ Root Intrusion ☐ Loose Brick ☒ **Deteriorated**
Infiltration: ☒ None ☐ Joint ☐ Cracks ☐ Mortar ☐ Roots ☐ Wall

CHIMNEY DETERIORATION

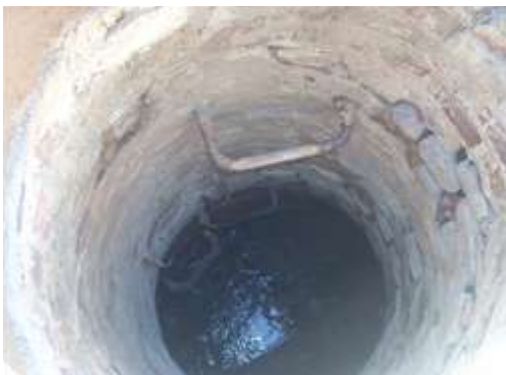
Defect 2

Steps Count: **4** Missing: **1** ☒ **Corroded**

MISSING AND CORRODED STEPS

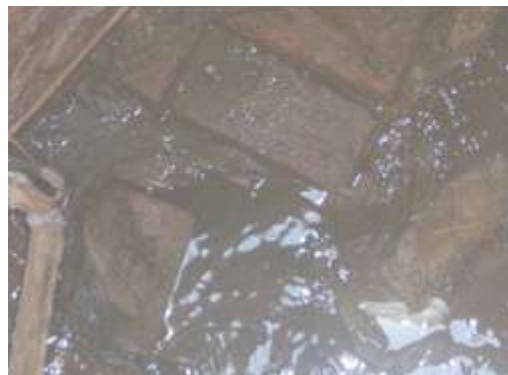
Defect 1

Bench ☒ Exists Material: **Brick** ☐ Parged
Condition: ☐ Sound ☐ Cracked ☐ Root Intrusion ☒ **Deteriorated** ☐ Leaks ☐ Debris

BENCH DETERIORATION

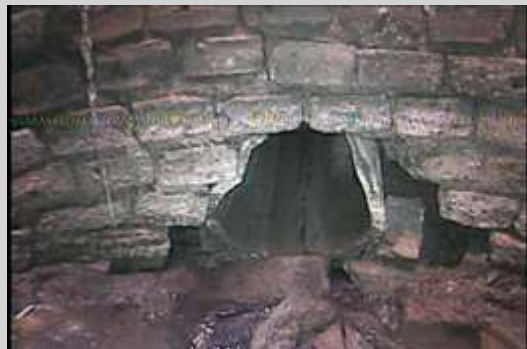
9 O'Clock Inflow

Infiltration: **None** Pipe Seal Cond: **Broken**
